**DELAWARE RIVER BASIN
KINNEYVILLE CREEK, WAYNE COUNTY
PENNSYLVANIA**

LAKE COMO DAM

**NDI ID NO. PA-00130
DER ID NO. 64-16**

**PHASE I INSPECTION REPORT
NATIONAL DAM INSPECTION PROGRAM**

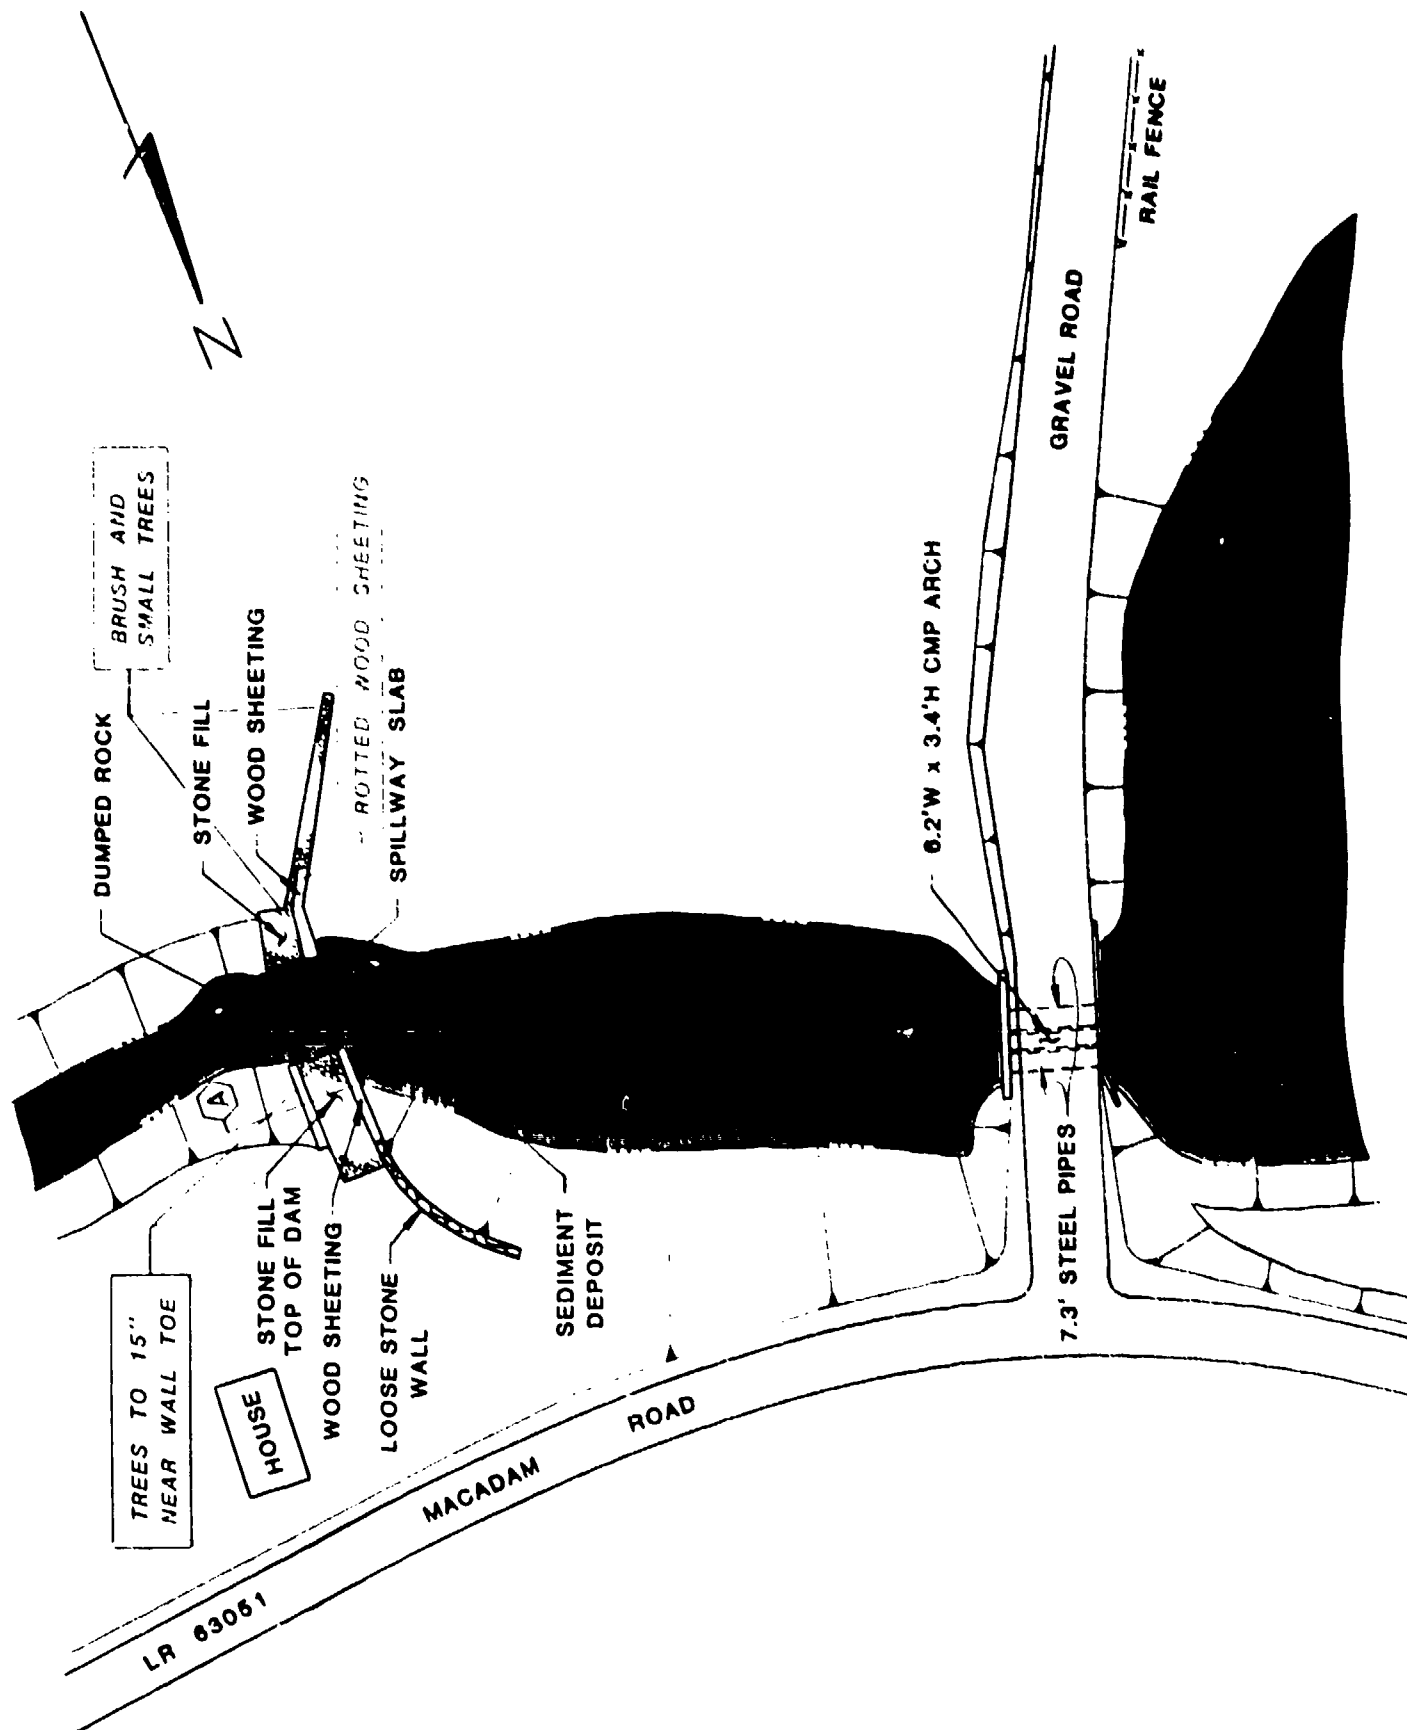
LAKE COMO DAM GENERAL PLAN - FIELD INSPECTION NOTES

a. General: The overall appearance of the dam is fair. Deficiencies observed during the field inspection are noted on the General Plan, Exhibit A-1, and are described in the subsequent paragraphs. The profile and typical sections of the dam are presented in Exhibits A-2 and A-4 and are based on field survey made on the day of the inspection. The survey datum for this inspection is based on the normal pool elevation 1508 above mean sea level established by the USGS (see Exhibit E-1, Appendix E). To convert the vertical dimensions as shown on the design drawing (Exhibit E-3) to the elevations used in this report, it is necessary to designate elevation 1508 to the sharp crested concrete weir. On the inspection date (June 24, 1981), the lake level was 0.1 foot above the spillway crest. Visible features of the dam are depicted in photographs presented in Appendix C.

b. Dam: Observations made during the field inspection reveal that the horizontal alignment of the dam is concaved in an upstream direction (see Exhibit A-1, Appendix A). The present alignment is similar to the alignment of the dam in 1965 (see upstream face photograph, Exhibit E-7). The upstream plank sheeting extends 33 feet to the left and the right of the spillway. Beyond the termination of the sheeting, a 3-foot wide loose stone wall extends on each abutment of the dam for a total distance of 102 feet. The purpose of this loose stone wall, protruding from a few inches to a maximum of 1.5-feet above the ground level, appears to be for protection of the abutments in the event of overtopping. The plank sheeting on the upstream face of dam extends above the crest of the rockfill embankment, as shown in Exhibit A-4 and photograph 5, Exhibit C. The sheeted upstream slope of the dam has a slope of 1V:0.9H (1 Vertical on 0.9 Horizontal). The plank sheeting to the right of the spillway endwall is rotted. The top width of the rockfill crest varies between 12.5 to 13.5 feet. The right end of the crest is covered with brush and small trees.

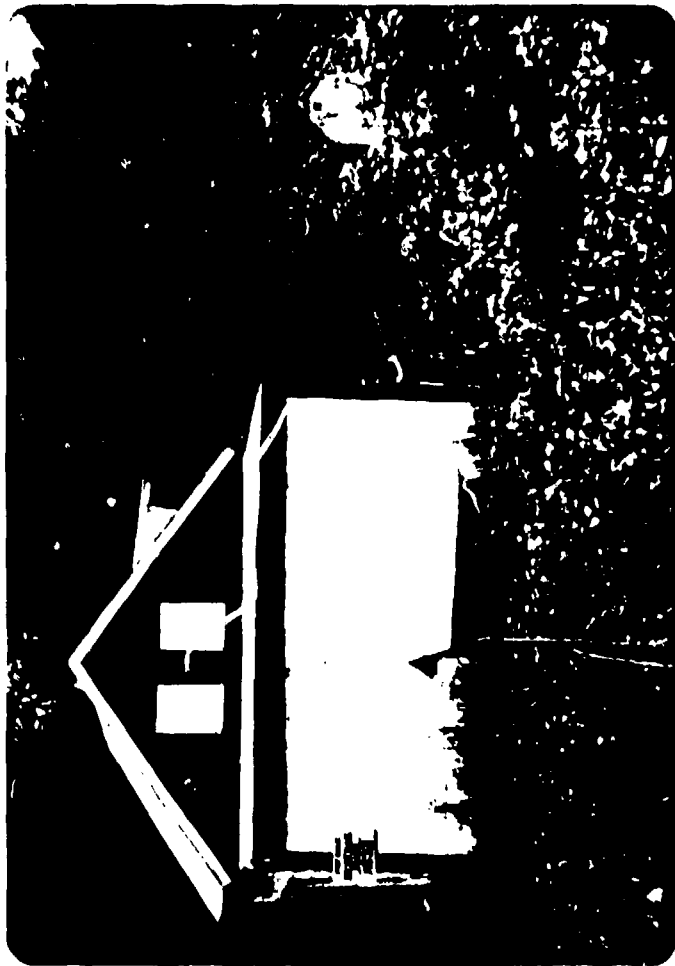
ITEM	OBSERVATIONS/REMARKS/RECOMMENDATIONS	NDI# PA - 00130
SLOPES: RESERVOIR	Wooded slopes around reservoir vary from 5 to 10 percent. There are no slope conditions that would affect the safety of the dam.	
SEDIMENTATION	Slight.	
DOWNSTREAM CHANNEL (OBSTRUCTIONS, DEBRIS, ETC.)	None. Natural wooded channel with highway culvert about 1500' downstream.	
SLOPES: CHANNEL VALLEY	Natural wooded slopes (1V on 1H to 1V on 2H) 10'± high at dam and 30'± high at downstream highway culvert.	
APPROXIMATE NUMBER OF HOMES AND POPULATION	Along the first 2000 feet stretch downstream of the dam: One occupied home, 15 feet above the streambed; one unoccupied, 11 feet above the streambed and a Lumber Company storage building, 28 feet above streambed (see Photographs 17,18 and 19, Appendix C).

18. 1 STORY HOUSE, PRESENTLY VACANT
(STREAM 40' IN BACK OF HOUSE)

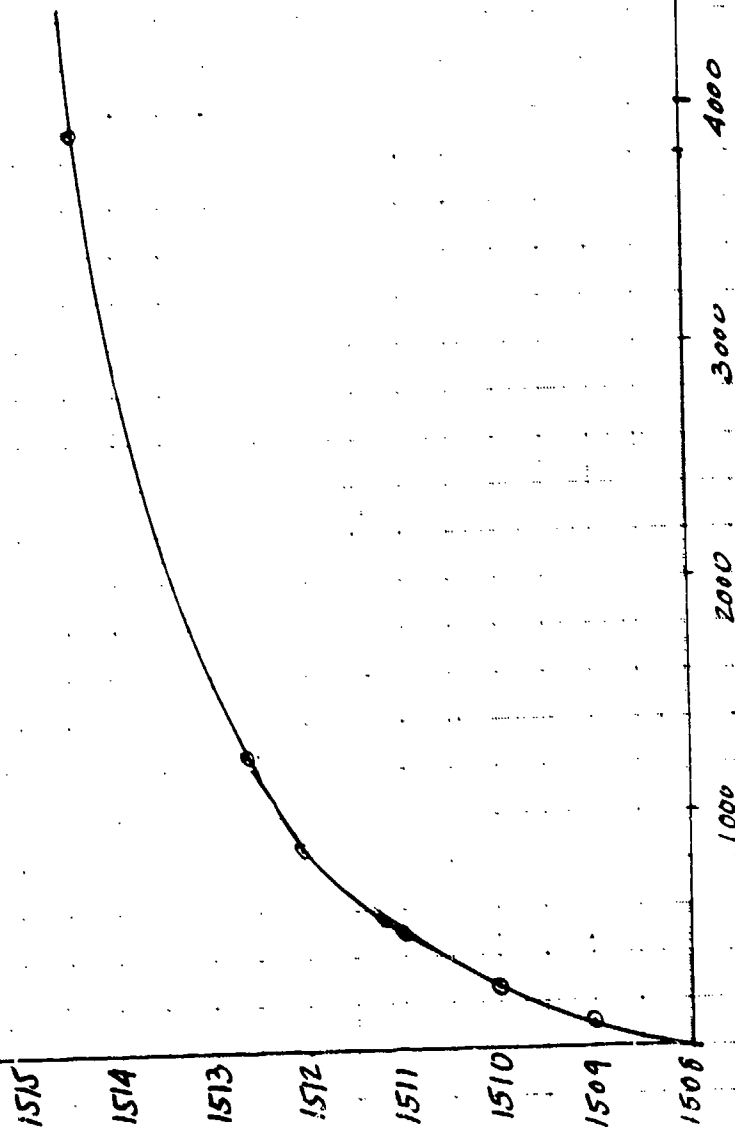
D-4

d. Downstream Conditions: The spillway and dam crest overtopping discharge capacities are not affected by tailwater conditions for the entire range of discharges considered in this study (see Sheet D-4, Appendix D). Failure of the dam may result in flooding of one dwelling, located on the left bank of Kinneyville Creek and approximately 1300 feet downstream of the dam. The observed downstream conditions indicate that a low hazard classification is warranted for the Lake Como Dam.
